Membrane Foulant Identification

TROUBLESHOOTING MEMBRANE SYSTEMS

AVISTA MEMBRANE AUTOPSY PROCESS

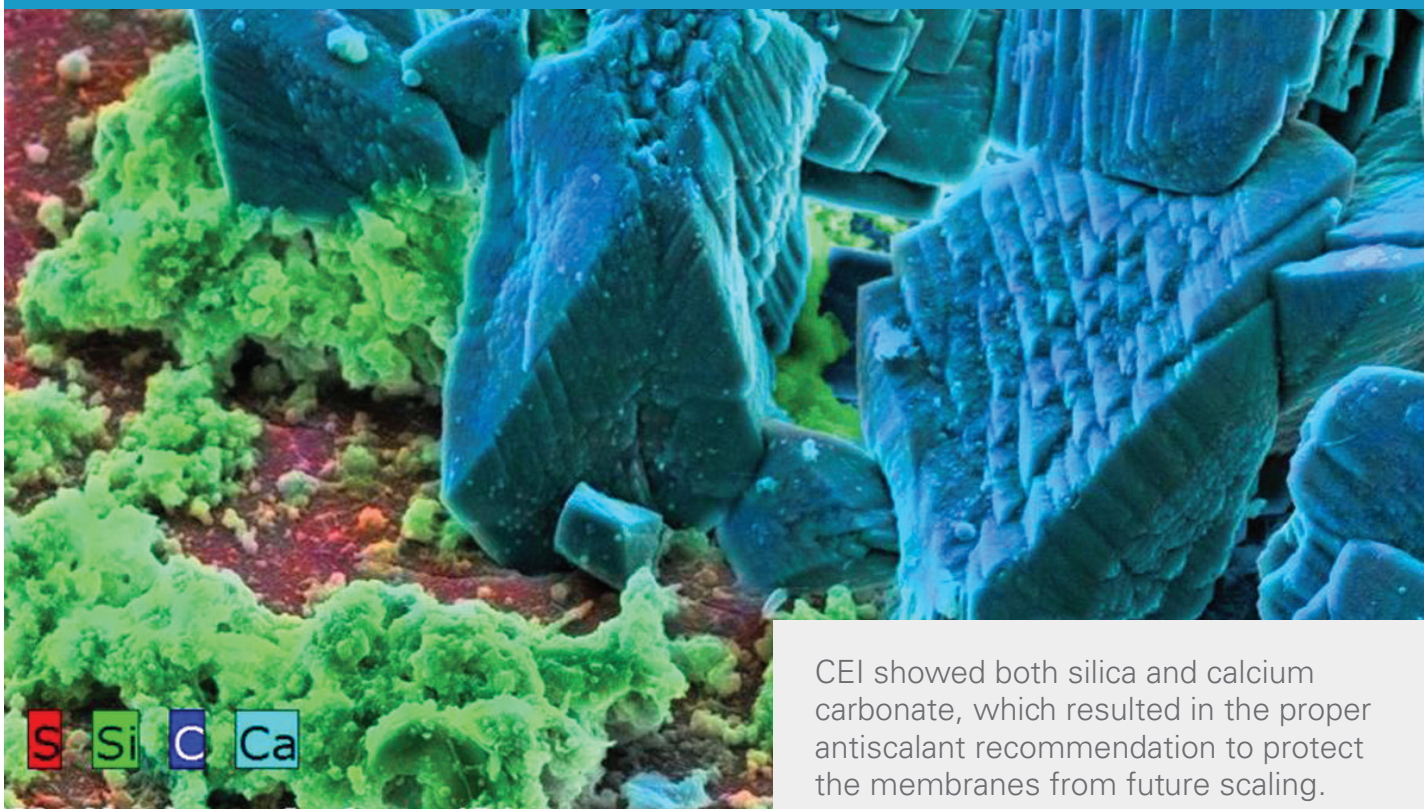
CEI showed both silica and calcium carbonate, which resulted in the proper antiscalant recommendation to protect the membranes from future scaling.

Additionally, it provided information on a cleaning sequence that removed the calcium carbonate layer first, followed by the silica scale.

The reverse osmosis (RO) element was received for an Avista membrane autopsy to determine why a second stage RO system had experienced a rapid increase in pressure after only six months of operation.

- The tail element weighed almost 50 pounds (22 kgs) more than a new element, a clear indication of severe scaling.
- The Avista membrane autopsy revealed crystals on the membrane surface.
- CEI identified the crystals as calcium carbonate scale layered on top of silica deposits.

Based on a review of an original feedwater analysis, the Avista membrane autopsy determined that both calcium carbonate and silica were within the inhibition capabilities of the on-line antiscalant.

- The antiscalant injection rate was correct, and the system recovery was within design parameters.
- A new feedwater analysis was completed and revealed that the silica values had doubled over the summer.
- The higher silica values exceeded the capabilities of the scale inhibitor, which led to the extreme scaling.
